TP 13940E

THE DETECTION OF FROZEN CONTAMINATION ON AIRCRAFT SURFACES

A Report on Behalf of the "Representative Surfaces" Working Group

September 2002

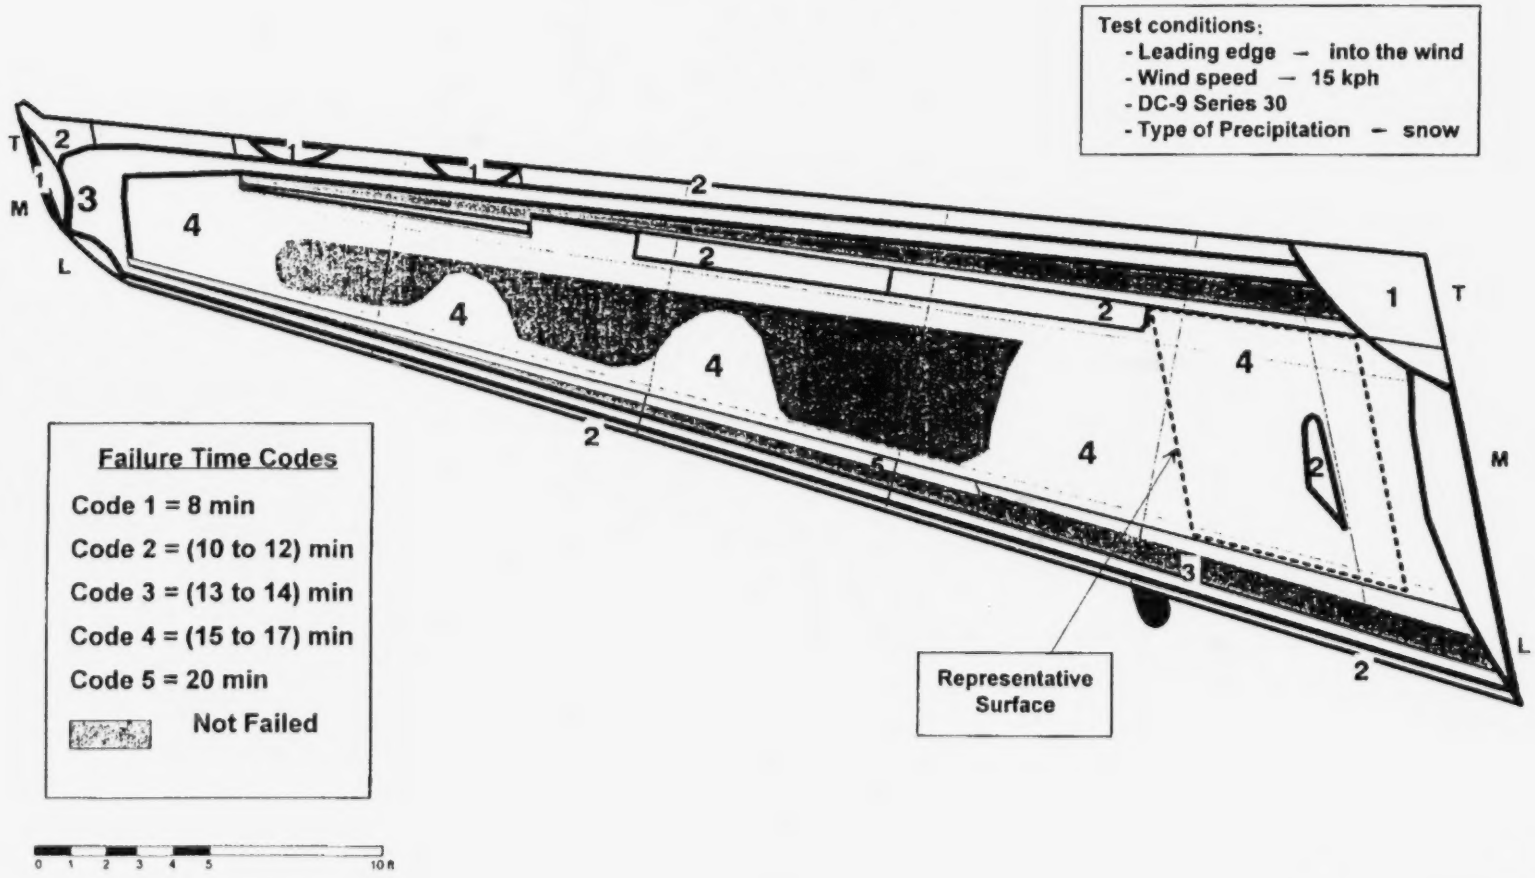
FIGURE 1
SAMPLE FAILURE PROGRESSION FOR A TYPE I FLUID
MARCH 06/95, Test ID: #L2

Pictorial data taken from a sample test conducted on a Douglas DC9 during the winter of 1994-95 is given in Figure 1, based on data from [3]. After some 10 to 12 minutes, failure of the Type I fluid, which had been used as an anti-icing fluid, extended over some 10% of the wing area, including a strip along the entire leading edge. However, with the exception of a small area at an access panel, the fluid on the representative surface area continued to absorb precipitation

until 15 to 17 minutes after initial fluid application. External test team observers identified the small failed area of fluid on the representative surface, but observers inside the aircraft did not identify this local fluid failure.

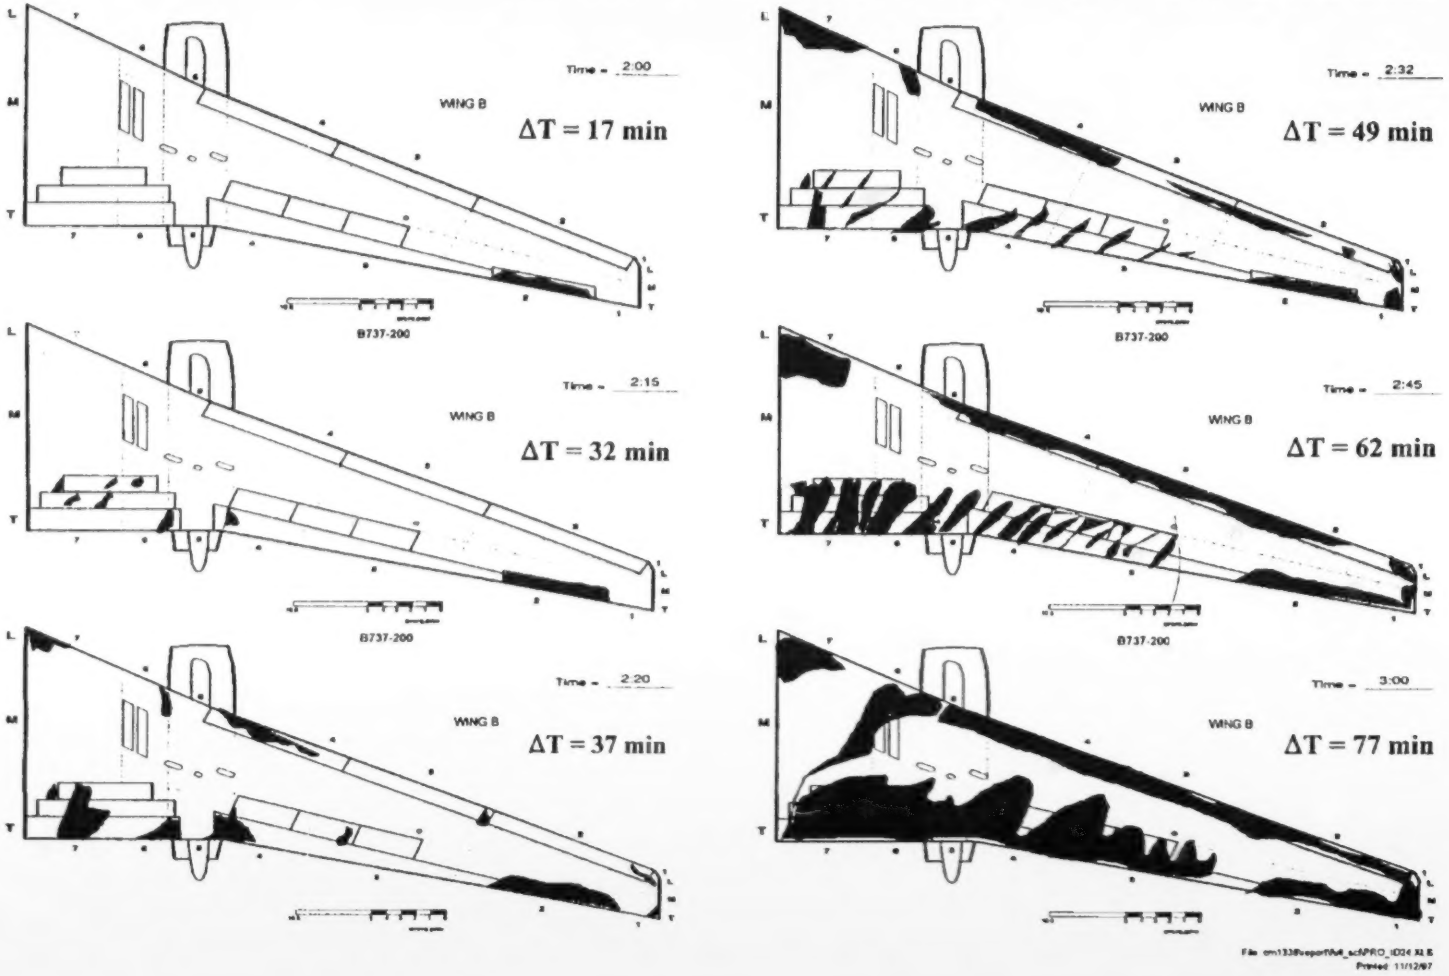
FIGURE 2
SAMPLE FAILURE PROGRESSION FOR A TYPE IV FLUID ON A BOEING 737
FEB. 21/97, Test ID: #24 [Wind: 6km/h, Temp. -3.2^0C, snow @ 20.9gm/dm^2/h]

Sample test observations of fluid failure initial onset and progression are shown in Figures 2 and 3 for a Boeing B-737 and a Fokker F-100, respectively. For the B-737 aircraft with leading edge devices and pylon-mounted engines, after first indications of slush build-up (fluid failure), the failure progresses on leading and trailing edges simultaneously, whereas on the hard-wing F-100 there is significant contamination on the trailing edge before the leading edge is seriously affected. (A comparison of times for contamination progression for the two aircraft cannot be made because of the different test conditions.)

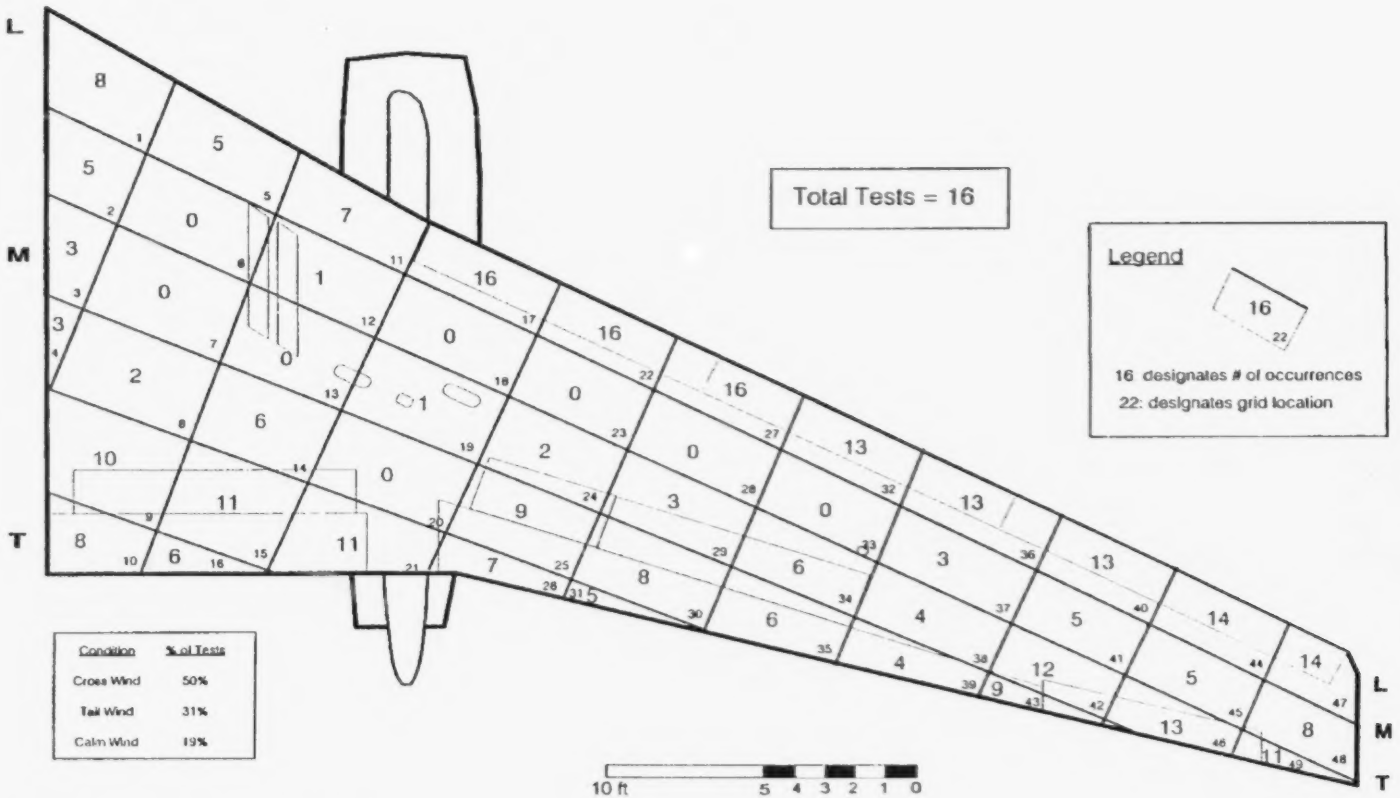
FIGURE 4
FREQUENCY OF CONTAMINATION DISTRIBUTION (FLUID FAILED) FOR FAILURE PROGRESSION TO 10% OF WING AREA ON A BOEING 737

In Figures 4 and 5 examples of frequency of occurrence of failure at a given location are given for the same two aircraft. The wings have been marked out in an arbitrary grid pattern and the number of times failure has occurred within a given grid area by the time 10% of the total wing area is contaminated is indicated. In the case of the B-737 the representative surface had evidence of fluid failure in only one of 16 tests, whereas failure occurred at the leading edge, immediately outboard of the pylons, in every test. In the case of the F-100, in 13 of 13 tests failure occurred at the trailing edge and on the spoilers whereas failure occurred at the leading edge 1/3 of the time or less. The F-100 provided by American Airlines and used for the tests did not have a representative surface marked on the aircraft. The Fokker F-28 aircraft with similar wings (and operated by Canadian carriers), which would be expected to have similar failure patterns, had representative surfaces marked by a full chord length band in the areas identified by grids 30, 31 and 32 of Figure 5. As can be seen in the figure, such representative surfaces would be valid at the trailing edge but not at the leading edge.

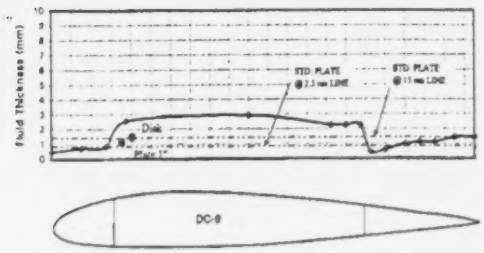
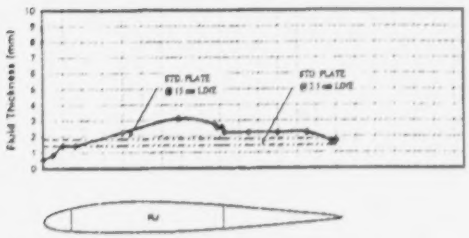
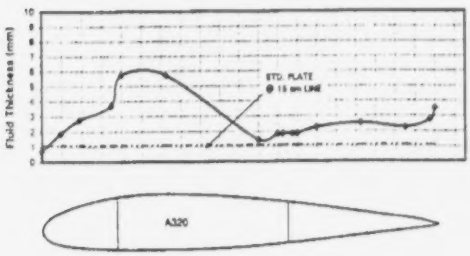
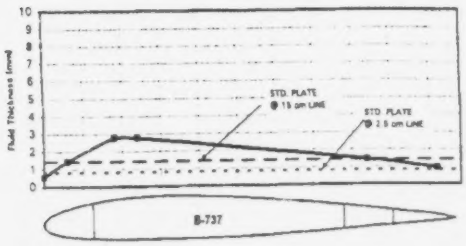
TYPE IV FLUID THICKNESS (STABILIZED) PROFILE OF A DC-9, RJ, AIRBUS A320, AND BOEING 737

In Figure 6 sample thickness distribution measurements for four different aircraft are illustrated. The measurements were repeated at intervals after initial application and were observed to remain stable after 4 to 6 minutes for Type I fluids and 10 to 14 minutes for Type IV fluids. The examples serve to show the wide variation of thickness distributions that can occur in part as a
